**RE: Operations and Maintenance Plan Approval for the Columbia Tailings Site, Rico,
Colorado, RV#960119-1**

ATTACHMENT 1: COLUMBIA TAILINGS OM&M DRAWINGS

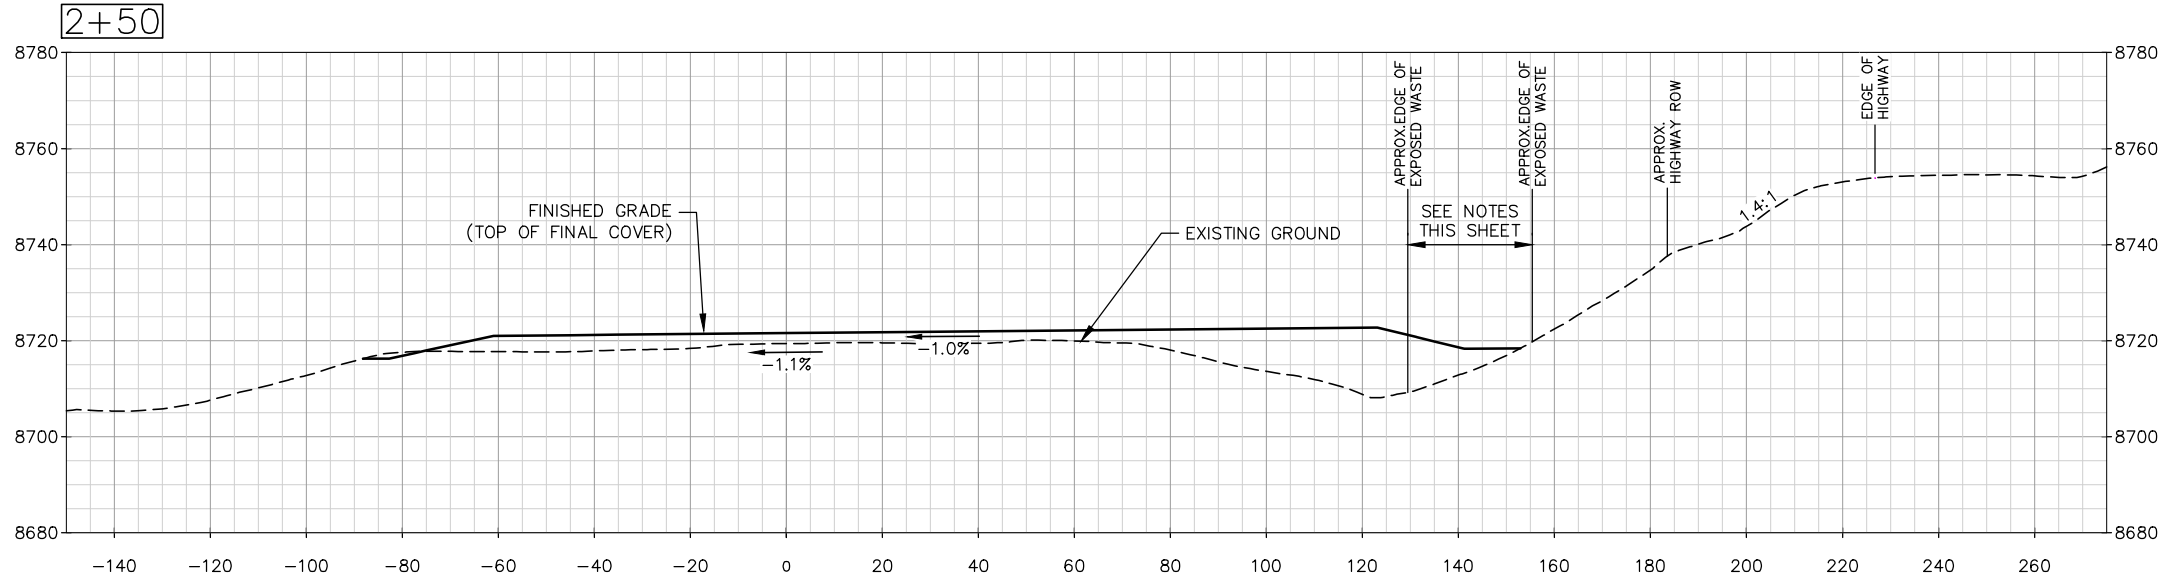
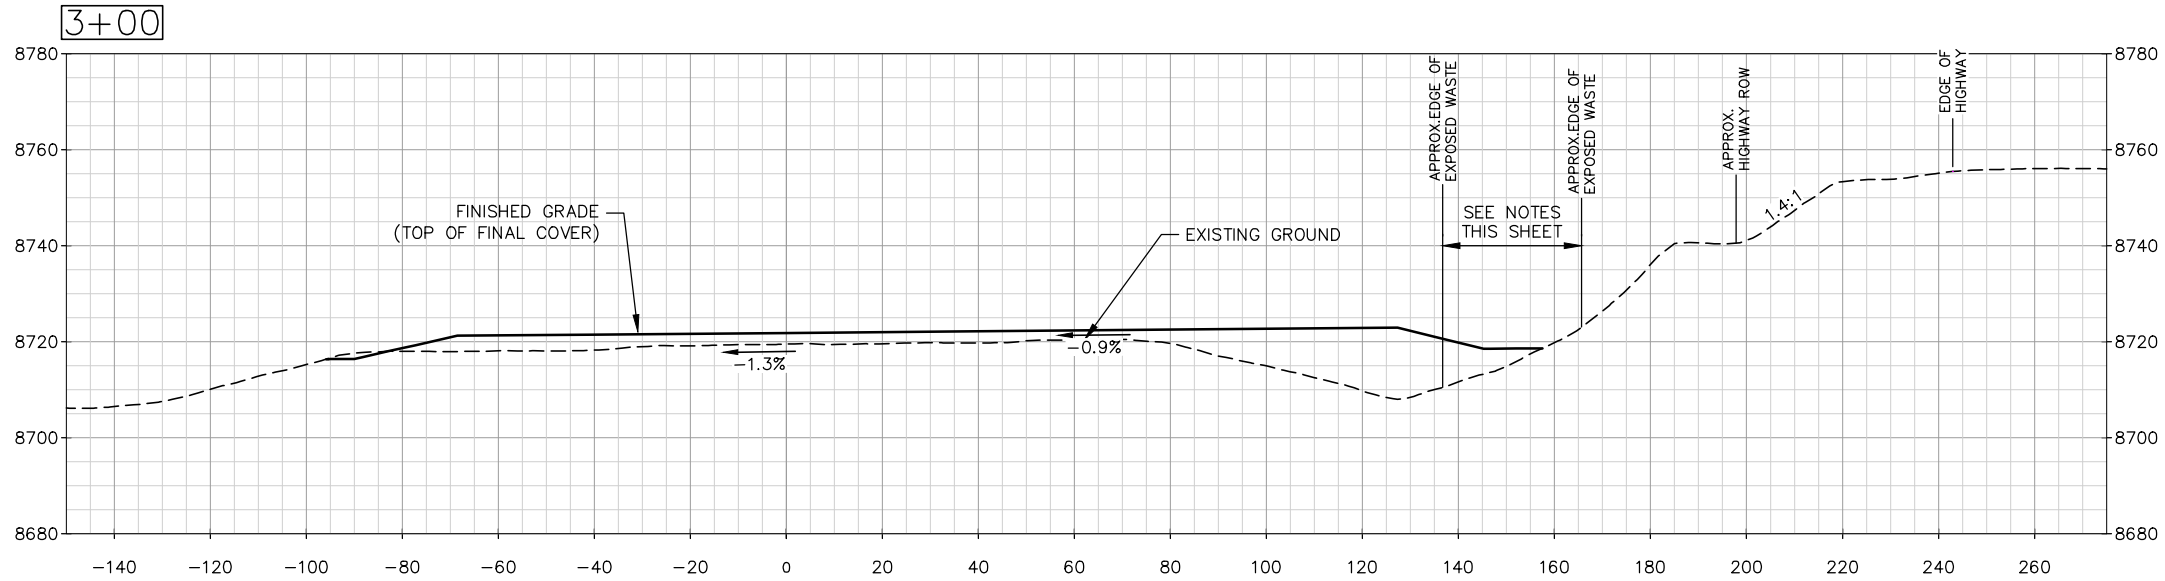
TITLE:	FIGURE
COLUMBIA TAILINGS VCUP OM&M CROSS SECTIONS	4B
PROJECT:	
Dolores County, Colorado

1. REMOVE EXPOSED MINE WASTE TO A DEPTH OF 1-FT AND BACKFILL WITH CLEAN COVER MATERIAL.
2. CONSOLIDATE REMOVED MINE WASTE MATERIAL ALONG THE EASTERN BOUNDARY OF THE COLUMBIA TAILINGS PILE.
3. AVOID DISTURBING EXISTING TREES TO THE MAXIMUM EXTENT POSSIBLE ON THE SLOPE ABOVE THE COLUMBIA TAILINGS PILE.
4. REVEGETATE ALL BACKFILLED AND DISTURBED AREAS ON THE SLOPE ABOVE THE COLUMBIA TAILINGS PILE.

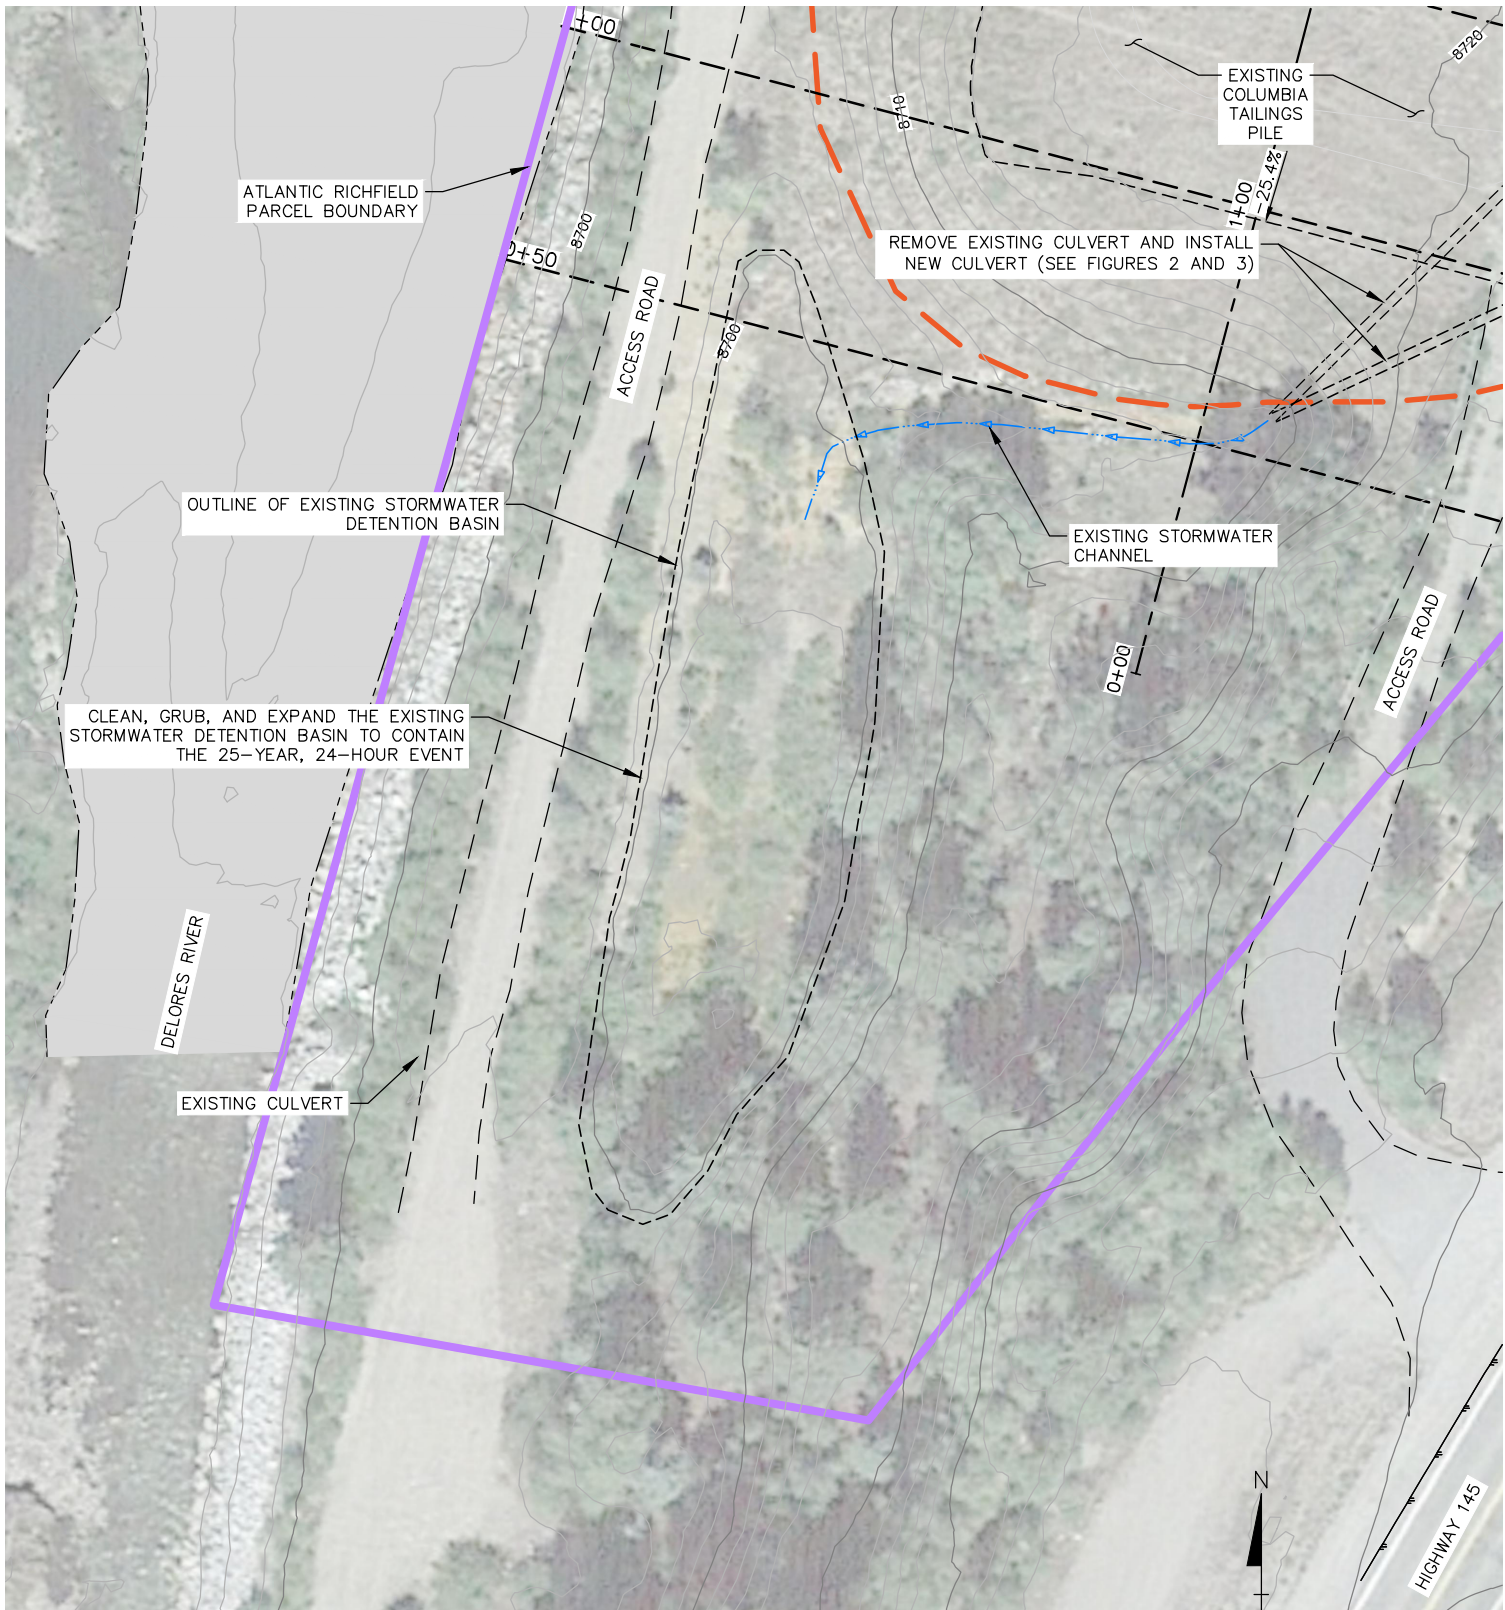
SITE PLAN W/ AERIAL PHOTO BACKGROUND IMAGE

REFERENCE NOTE: AERIAL PHOTOGRAPH BACKGROUND IMAGE IS A DRONE ORTHOMOSAIC, DATE OF IMAGE ACQUISITION JULY 18, 2023.
